# Why Does Bareilly Flood?

*A Systemic & Field-Evidence Analysis of Urban Drainage Failure*

## Focus Area: Model Town, Bareilly

Case Study #2 | April 2026

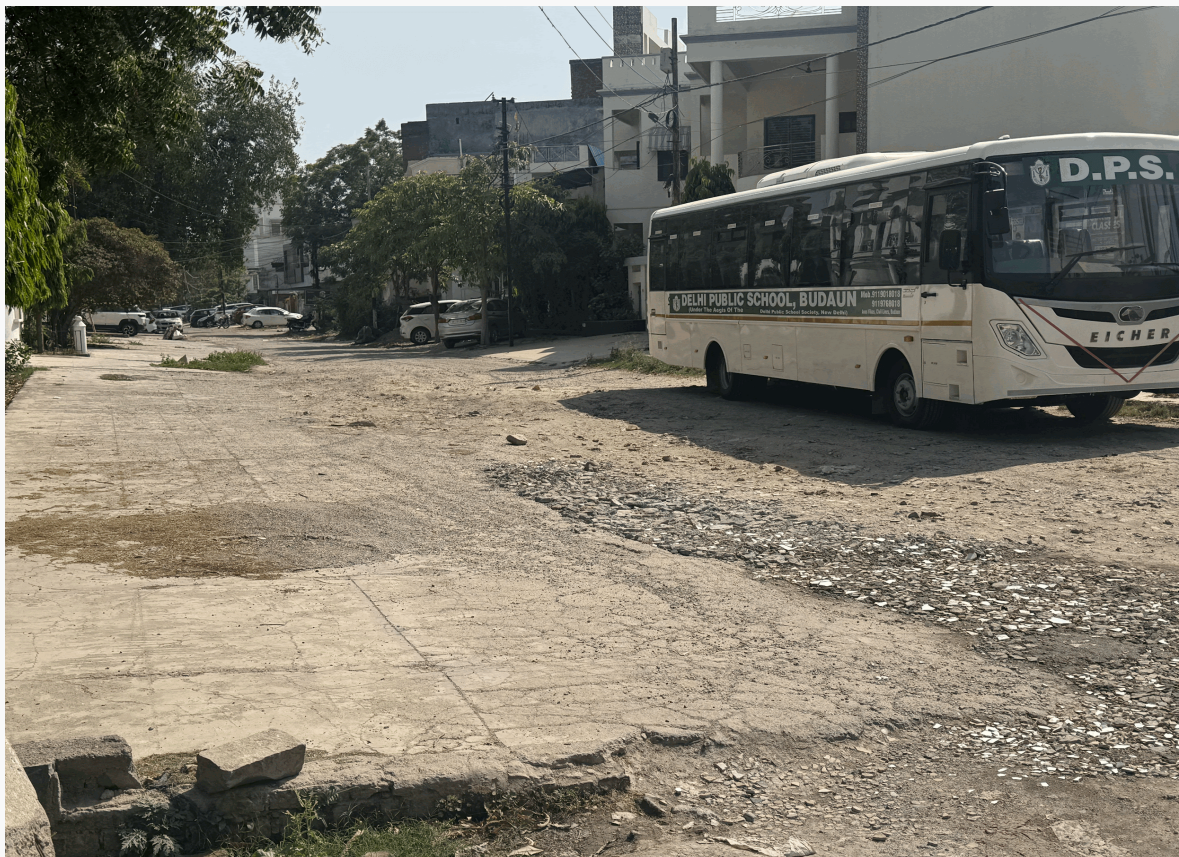
**Fig 1** — DPS school bus navigating deteriorated road surface adjacent to Model Town. Gravel displacement and road surface failure visible — consistent with long-term water damage to the road base.

**Proves:** Active road surface degradation from drainage overflow; large vehicles navigating damaged road confirm the scale of infrastructure failure.

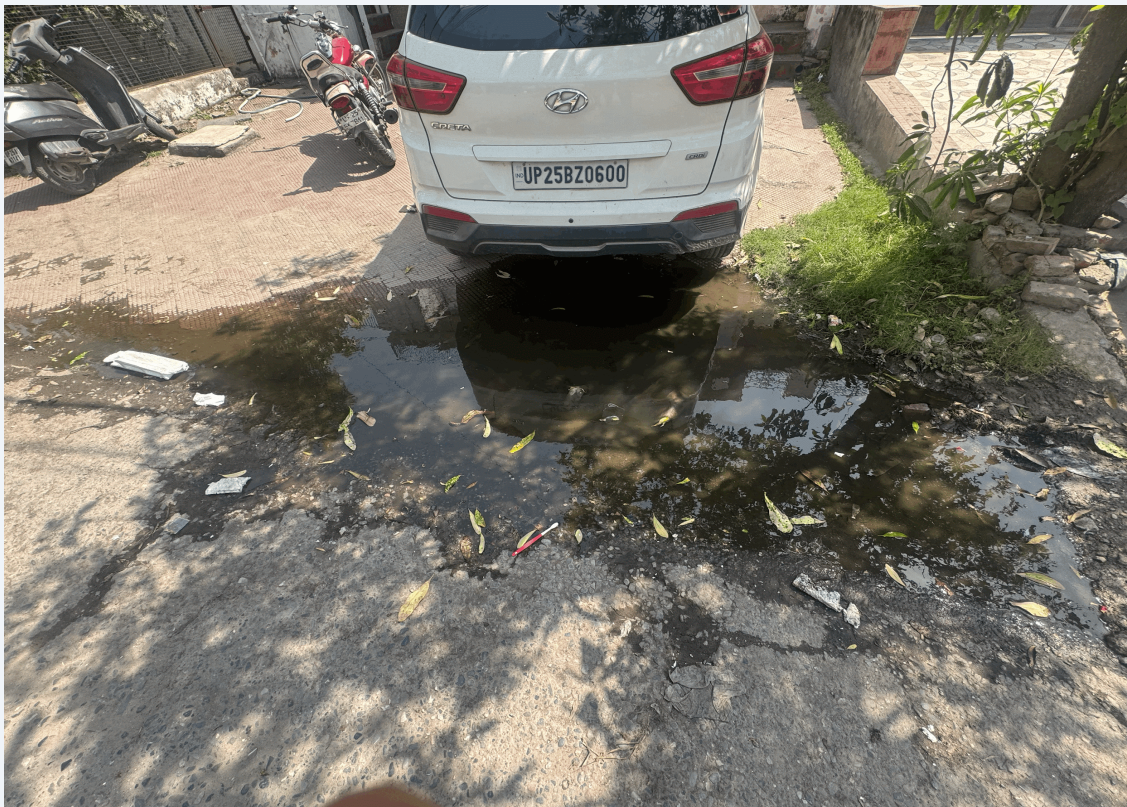
**Fig 2** — Stagnant drainage water pooling beneath and around parked vehicles in residential areas. Dark water colour indicates contamination — probable sewage mixing with surface drainage.

**Proves:** Stagnant water in dry weather conditions confirms permanent overflow condition, not storm-event flooding. Drainage system provides no containment.

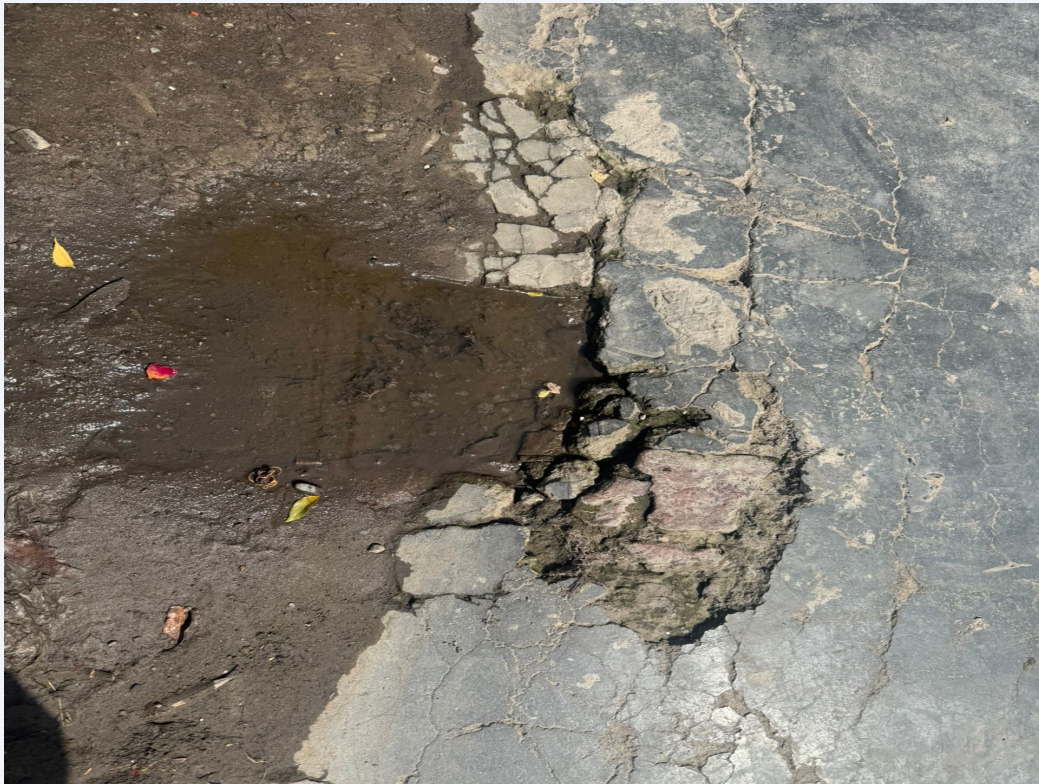
**Fig 3** — Close-up of drain boundary: cracked and structurally compromised edge, with water pooling at the paved/unpaved surface transition. Drain unable to contain or direct water flow.

**Proves:** Structural drain failure confirmed. Cracked edges, water spillover, and absence of directional flow demonstrate that blockage is compounded by physical infrastructure collapse.

| Level | Timeframe | Recommendation | Expected Impact |
|---|---|---|---|
| Level 1 | 0–3 months | Structural inspection of all drain edges and channel walls within colony boundary. Map all crack locations. Document damage severity. This is data collection, not repair — and it is required before any repair can be designed. | Produces a damage inventory — prerequisite for all subsequent structural work |
| Level 2 | 3–9 months | Drain reconstruction: replace structurally compromised drain sections with new reinforced channel, sized to minimum 40–50 cm width. Design must account for current — not 1980s — impervious surface area. | Restores designed drainage capacity; eliminates structural overflow failure |
