# Why Does Bareilly Choke?

*A Systemic & Field-Evidence Analysis of Urban Traffic Failure*

**Focus Junction: Prem Nagar Chauraha, Bareilly**

| Report Type<br>Hybrid (Macro + Micro) | City<br>Bareilly, U.P. | Researcher<br>Chanpreet Singh Aneja | Field Date<br>30 March 2026 |

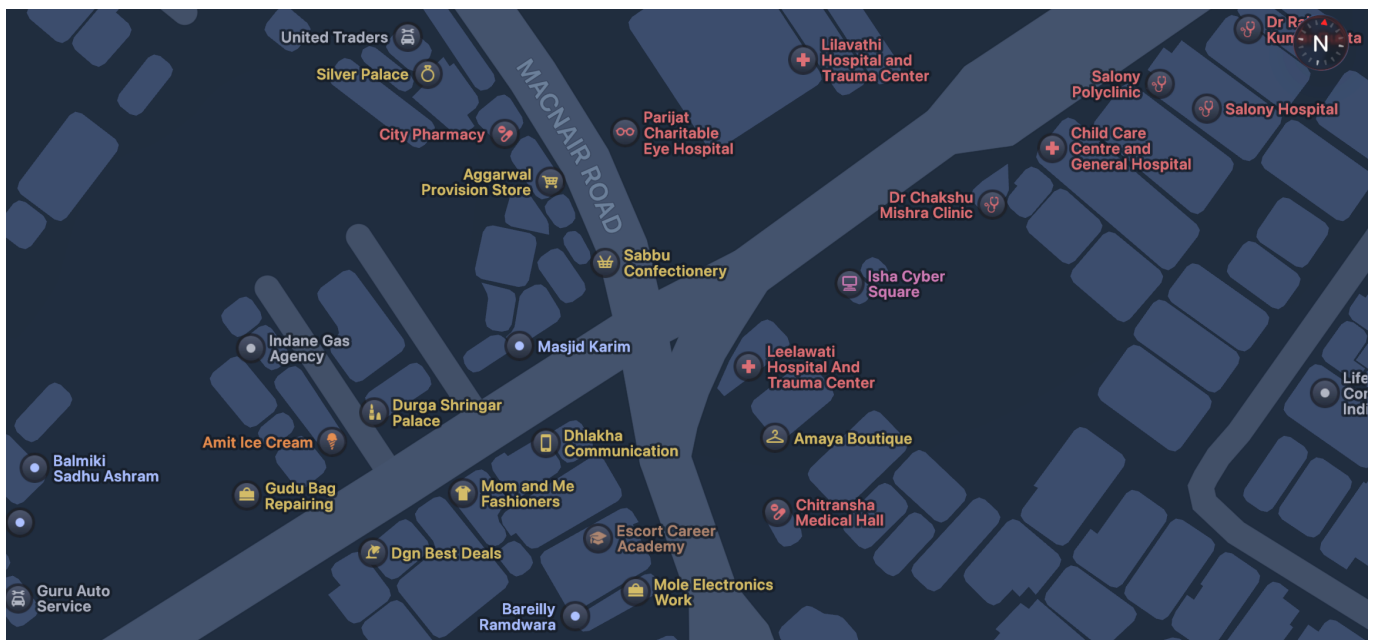
Fig 1 — MacNair Road area map showing Prem Nagar Chauraha surroundings and nearby land uses. (Source: ARF Field Study, March 2026)

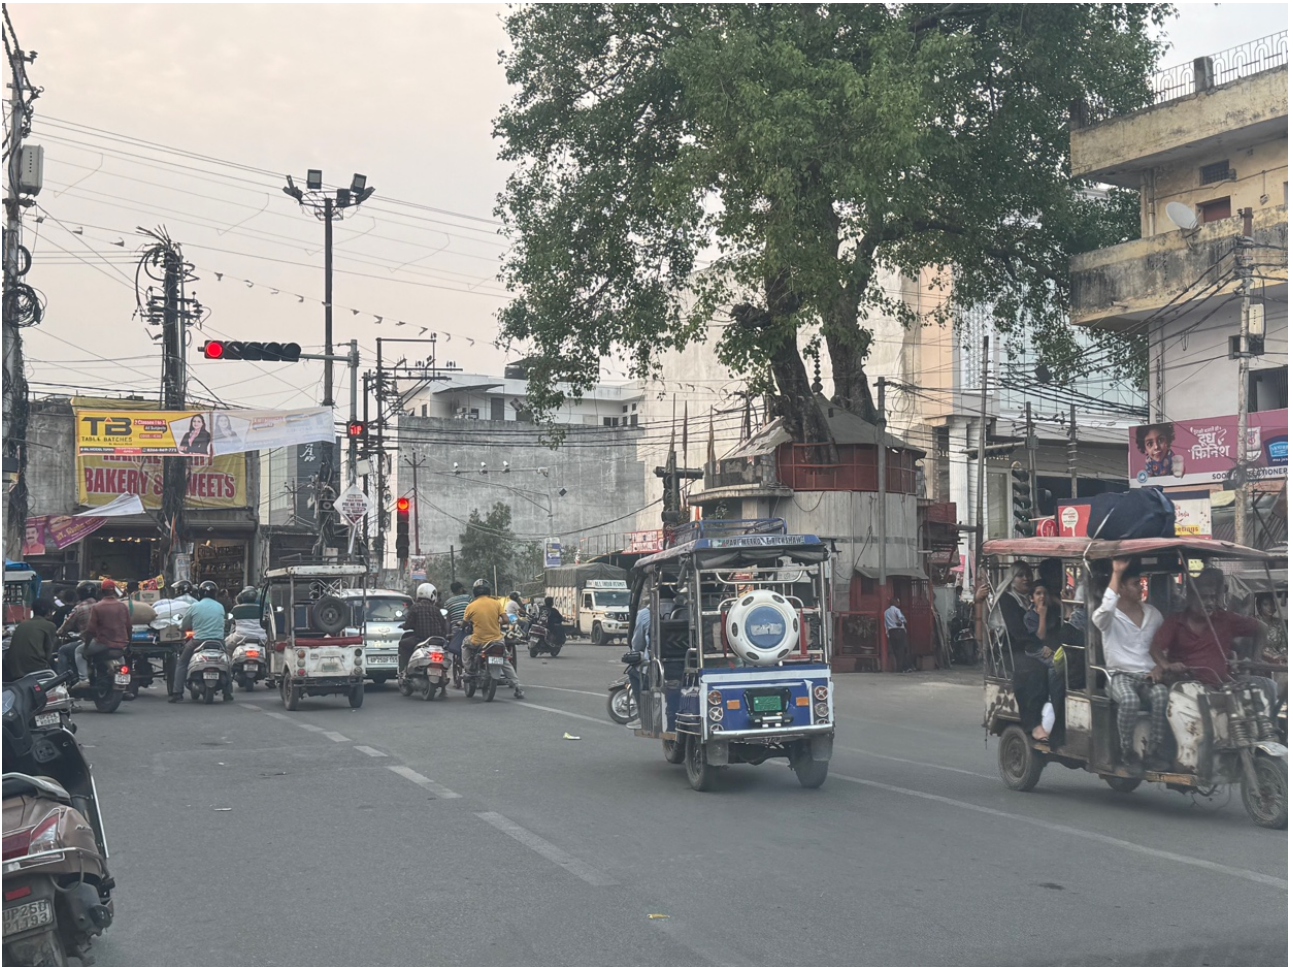
Fig 2 — Signal clearly at red; e-rickshaws and two-wheelers actively moving through the junction. Zero enforcement presence visible. (ARF Field Photo, 30 March 2026)

- Signal at red, vehicles in motion: photographically confirms red-light non-compliance as a systemic pattern, not an isolated event
- Zero enforcement personnel in both frames: consistent with 10-minute observation — enforcement is structurally absent, not temporarily displaced
- Central island temple structure: permanent physical obstruction restricting turning radii and driver sight lines — a design constraint that signal timing cannot compensate for
- Overhead wire cluster: indicates cumulative unplanned infrastructure growth; a practical constraint on smart signal upgrades
- Commercial frontage directly on road edge: zero buffer zone between retail activity and carriageway — pedestrian generation is immediate and continuous
- E-rickshaws dominant in both frames: validates the 38% composition count; visible mid-junction positioning confirms mid-lane stopping behaviour

| Level | Timeframe | Recommendation | Expected Impact |
|---|---|---|---|
| Level 1 | 0–3 months | Reduce signal cycle from 98 sec to 60–70 sec. Shorter, more frequent green windows improve throughput and reduce non-compliance incentive. | <i>Reduces queue carryover; reduces red-phase violation probability</i> |

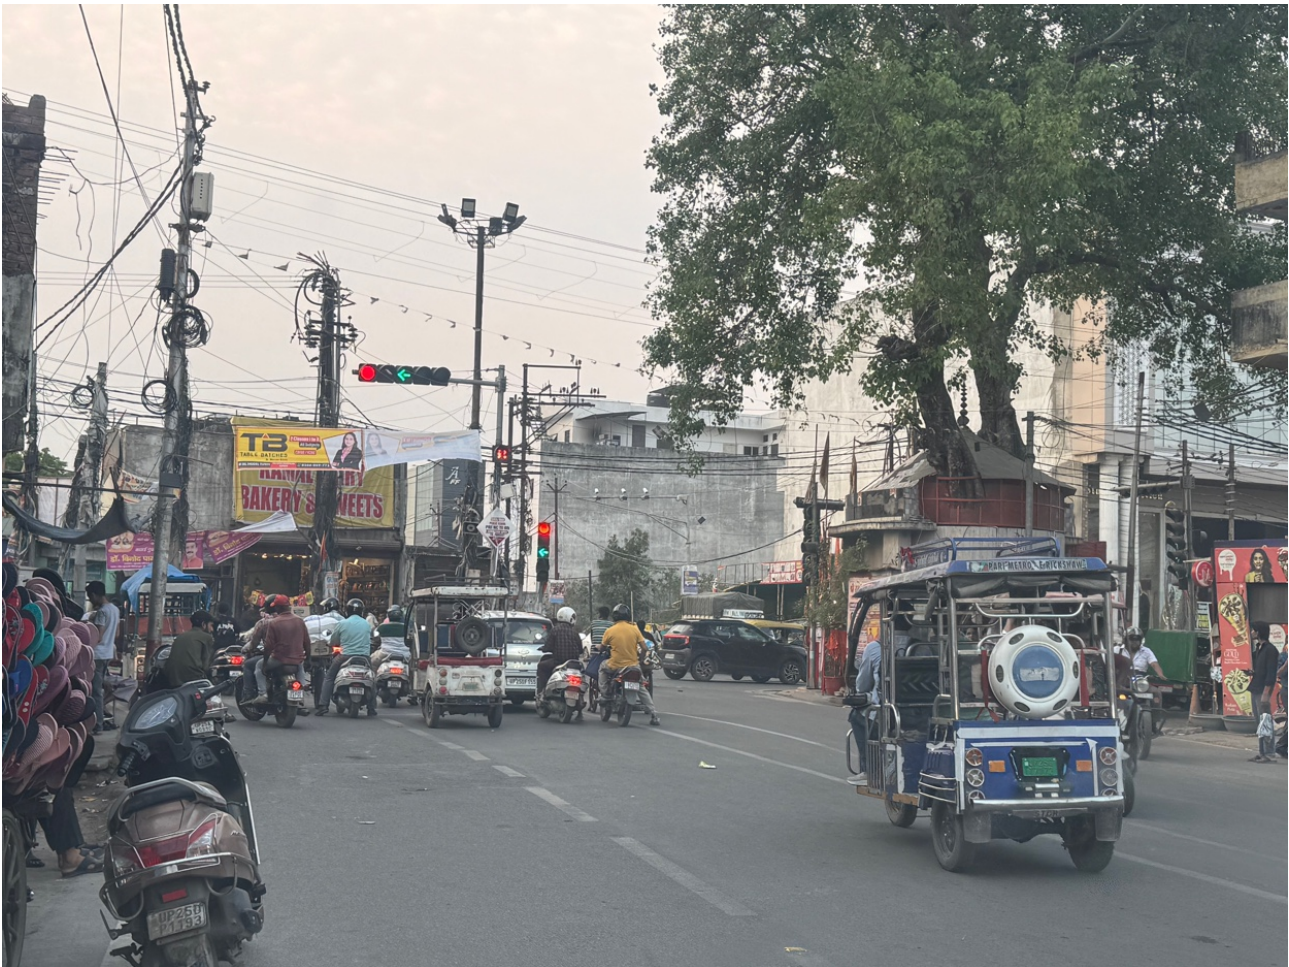
Fig 3 — Second frame from same observation window. Queue visible on approach arm. Central island temple structure restricts turning geometry and sight lines. (ARF Field Photo, 30 March 2026)
