CASE STUDY #3 — WHY DOES CONSTRUCTION NEVER END? — FULL REPORT

# Why Does Construction Never End?

A Systemic & Field-Evidence Analysis of Prolonged Road Construction Failure

Focus Corridor: Prem Nagar–Model Town Road, Bareilly

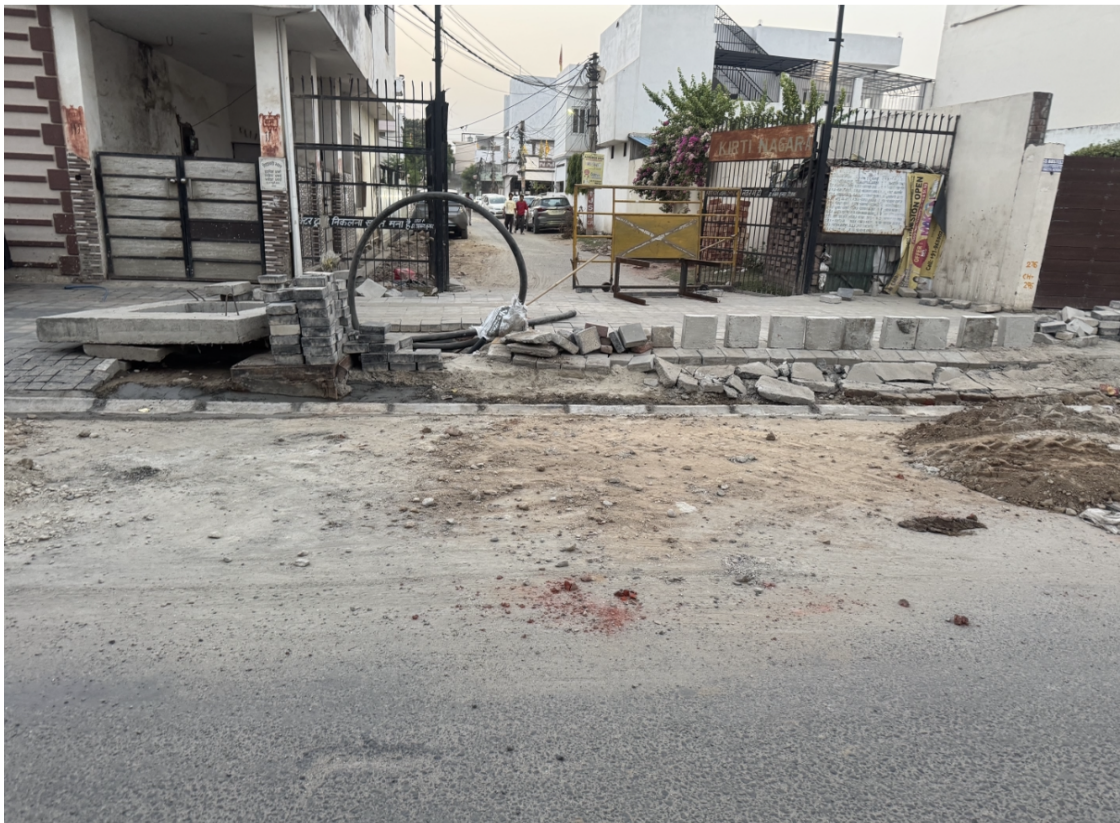
Fig 1

Utility pipe installation mid-footpath at Kirti Nagar colony gate. Paving blocks and concrete drain covers scattered with zero safety barriers. A school admission signboard is visible directly adjacent.

**Proves:** Active construction immediately adjacent to a school entrance with zero safety barriers — child safety hazard not classified as requiring special protection under current site management.

| Level | Timeframe | Recommendation | Expected Impact |
|---|---|---|---|
| Level 1 | 0–2 weeks | Install physical safety barriers (iron barricades or wooden horses) around all open excavations. Priority: school frontage points at Kirti Nagar gate and Little Millennium school. Cost: near zero. | <i>Immediate elimination of child safety hazard; IRC compliance on critical sites</i> |

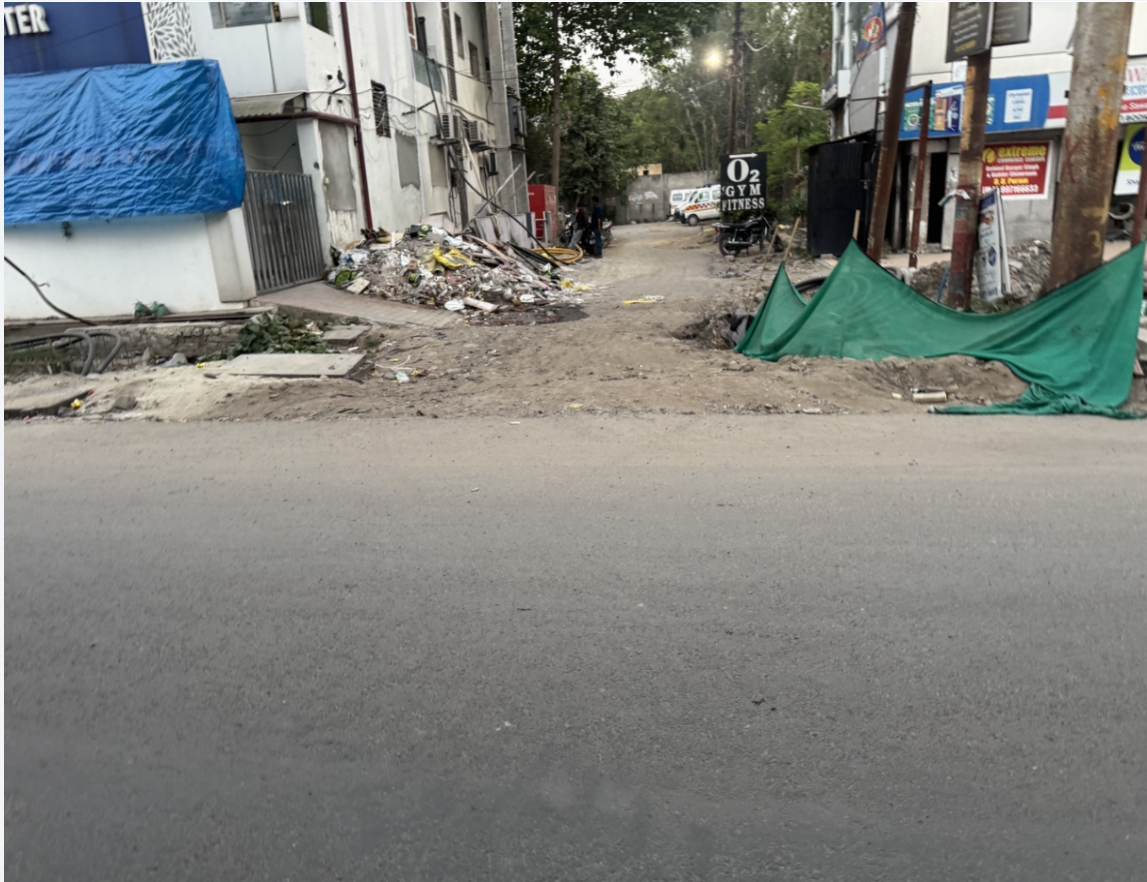
Fig 2

Active work zone mid-corridor: construction debris pile occupying approximately 50% of carriageway width. Token green safety net present but provides no physical barrier. Open excavation visible mid-road.

**Proves:** Effective carriageway width reduced to 40–50% of designed width by debris and excavation — direct evidence of mobility disruption and safety risk without any formal traffic management.

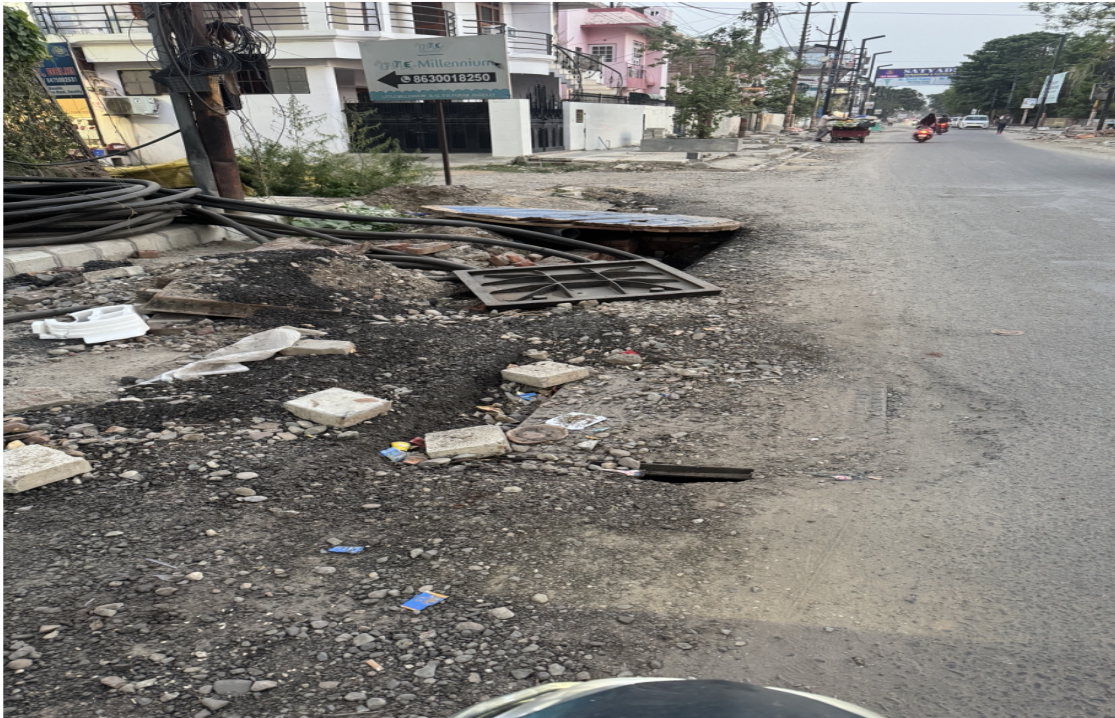
Fig 3

Displaced manhole cover adjacent to Little Millennium school frontage. Exposed pipes, loose rubble, gravel scatter, and an open drain access point — all immediately adjacent to a school entrance with zero barriers.

**Proves:** This is the most critical safety finding of CS3. An open drain/manhole access point with displaced cover and exposed sub-surface infrastructure, directly at a school entrance, with no barrier, no warning sign, and no lighting. This is not a construction site risk — it is a daily child safety emergency.

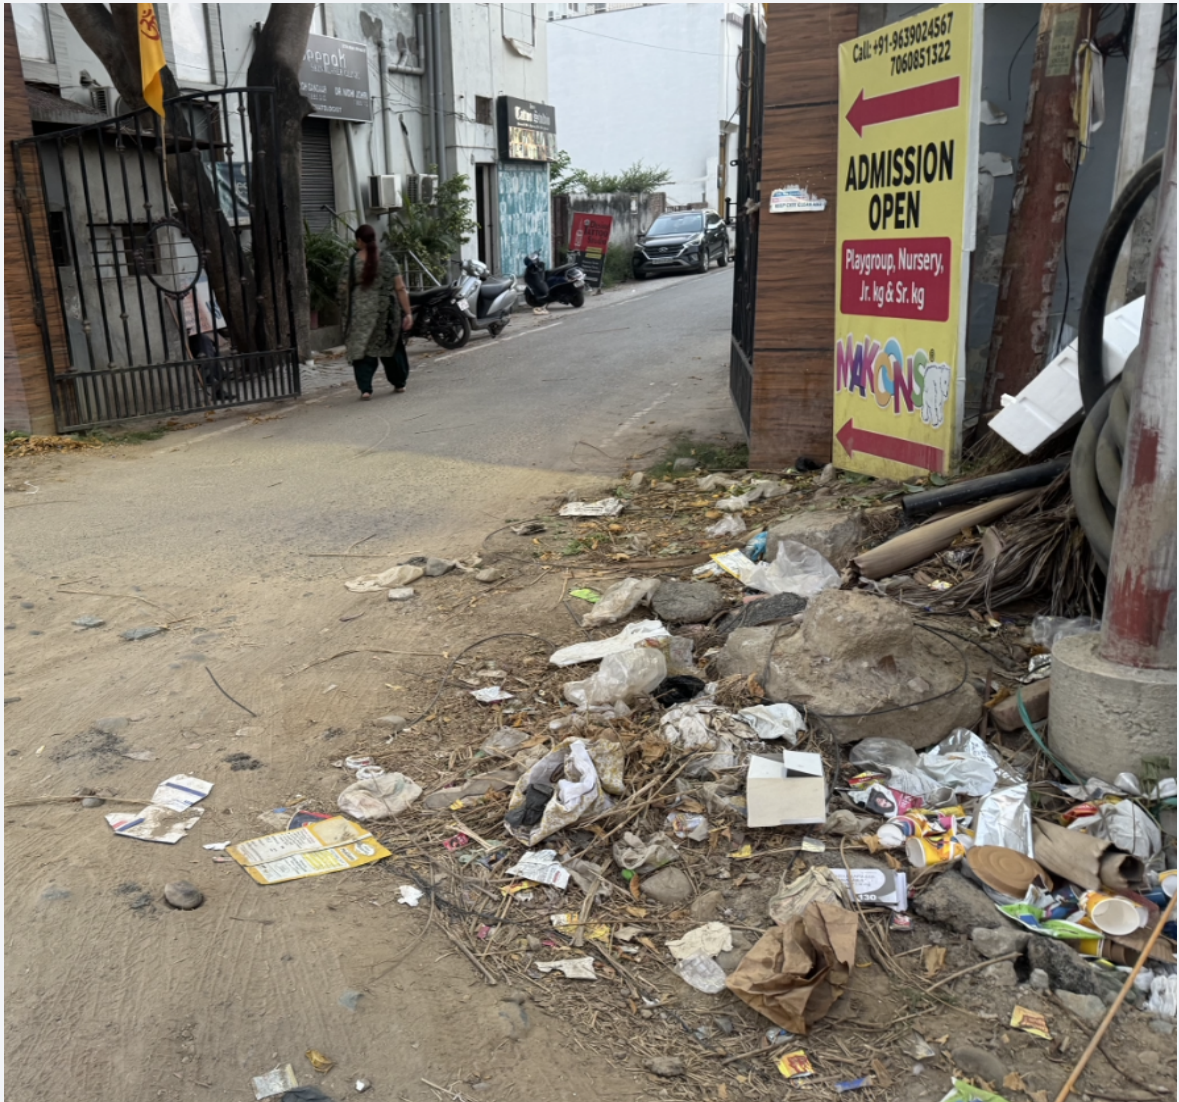
Fig 4

Solid waste accumulation at colony lane entry point. Drain inlet visible but completely obstructed by debris. Broken concrete and rubble blocking the paved/unpaved transition.

**Proves:** Drain inlet blockage by construction debris directly connects CS3's road failure to CS2's drainage failure. The same system failure — absent maintenance governance — expresses itself as a flooded colony in CS2 and a blocked drain in CS3.

| Level | Timeframe | Recommendation | Expected Impact |
|---|---|---|---|
| Level 1 | 0–3 months | Emergency drain inlet clearing: remove all construction debris blocking drain inlets along the corridor boundary before monsoon season. | <i>Prevents CS3 construction failure from compounding CS2 drainage failure during monsoon</i> |
